# **IndustrialPro™ Routers (SN/RAM Series) Wireless Modems**

**Including 67xx LTE Models**

Migration and Advanced Firmware Update Procedures  
Version 3.13/4.13

## Migration and update procedures

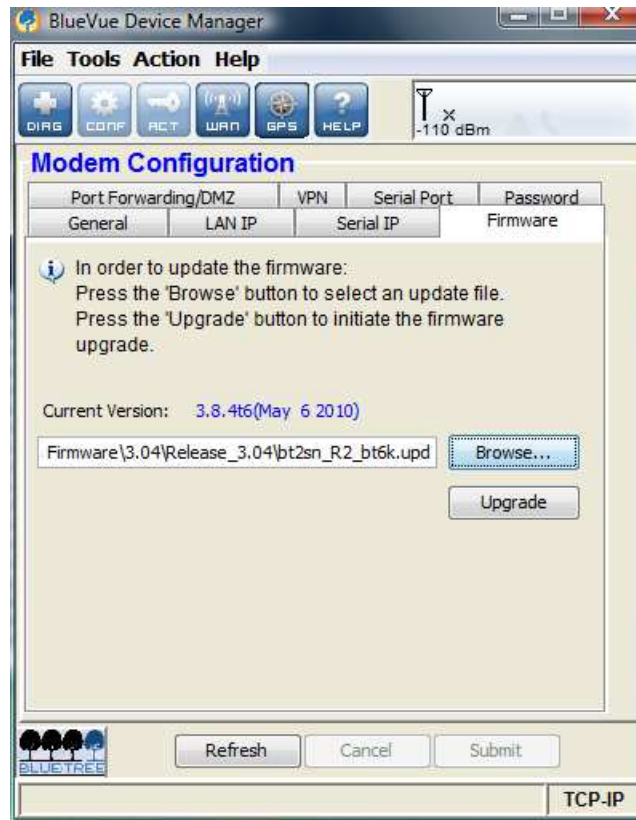
5. Select the **sn2bt\_R7\_bt6k.upd** file, then click "Upgrade"
6. Wait for the firmware update to end and the modem to restart (modem displays its boot LED pattern)
7. BlueVue Device Manager will eventually display that the upgrade could not be confirmed, click on OK and quit BlueVue Device Manager
